GAS FUEL POWER STATION REPLACES ROLLERS ON 4 SCREENS, SAVES £60 000

HOW WE CREATED VALUE

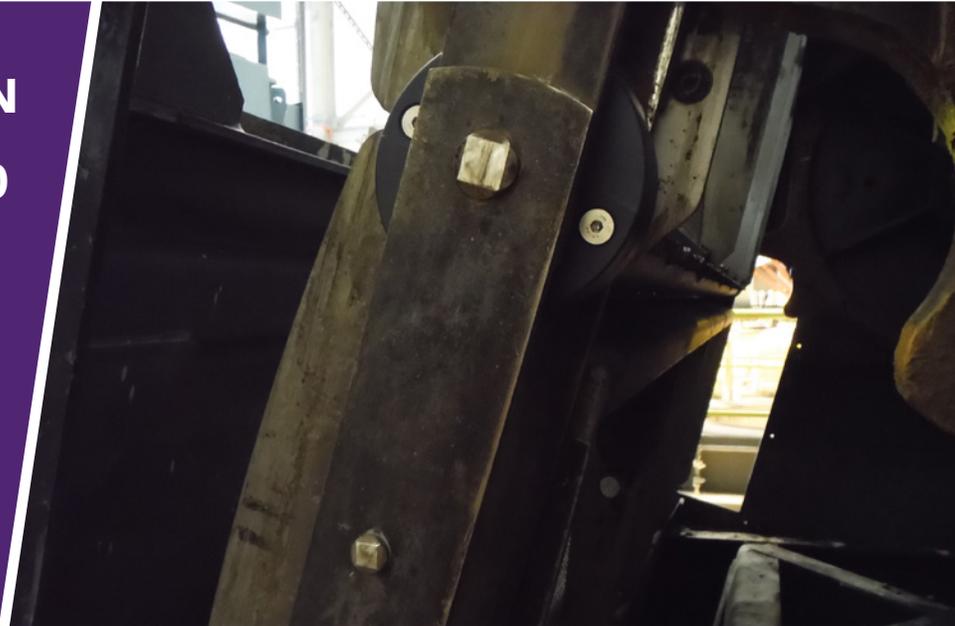
Old rollers replaced with new Split-Rollers without removing mainchains

Chain bush clearance dropped from 15mm to 2mm

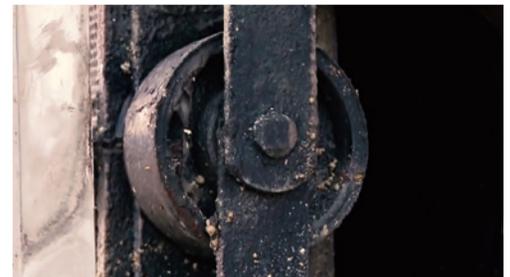
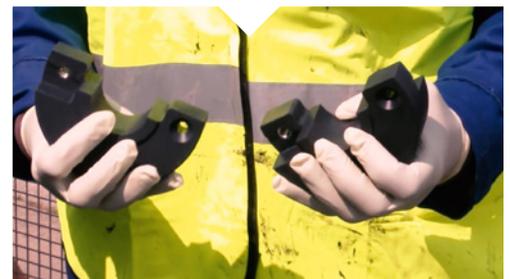
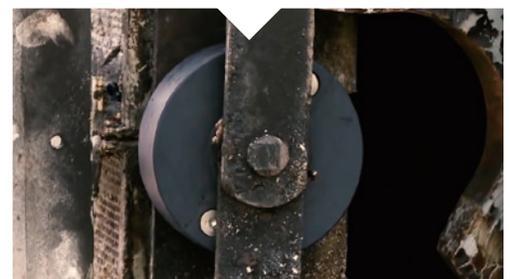
During a sales visit, an Ovivo rep had the opportunity to see one machine running without covers (screen run hours = 41528). The mainchain links were in good condition but the rollers had 15 mm of clearance to the chain bush. A new chain begins with less than 1 mm clearance and is replaced at 10mm. This excessive amount of clearance changed the efficiency of the screen by bringing moving parts into contact with the seals around the screen.

Without draining the chamber, the existing rollers were cut from the chain at deck level and Ovivo's quick and easy to install split rollers were fitted onto the screens. The clearance to the chain bush is now 2 mm, given that the bush had also worn, but well within the design parameters for efficient operation.

The process was completed in two days.
